## **ABORIGINAL CULTURAL HERITAGE ASSESSMENT**

## Cowra Heavy Vehicle By-Pass

Cowra, NSW.

Doug Williams  
May 2016

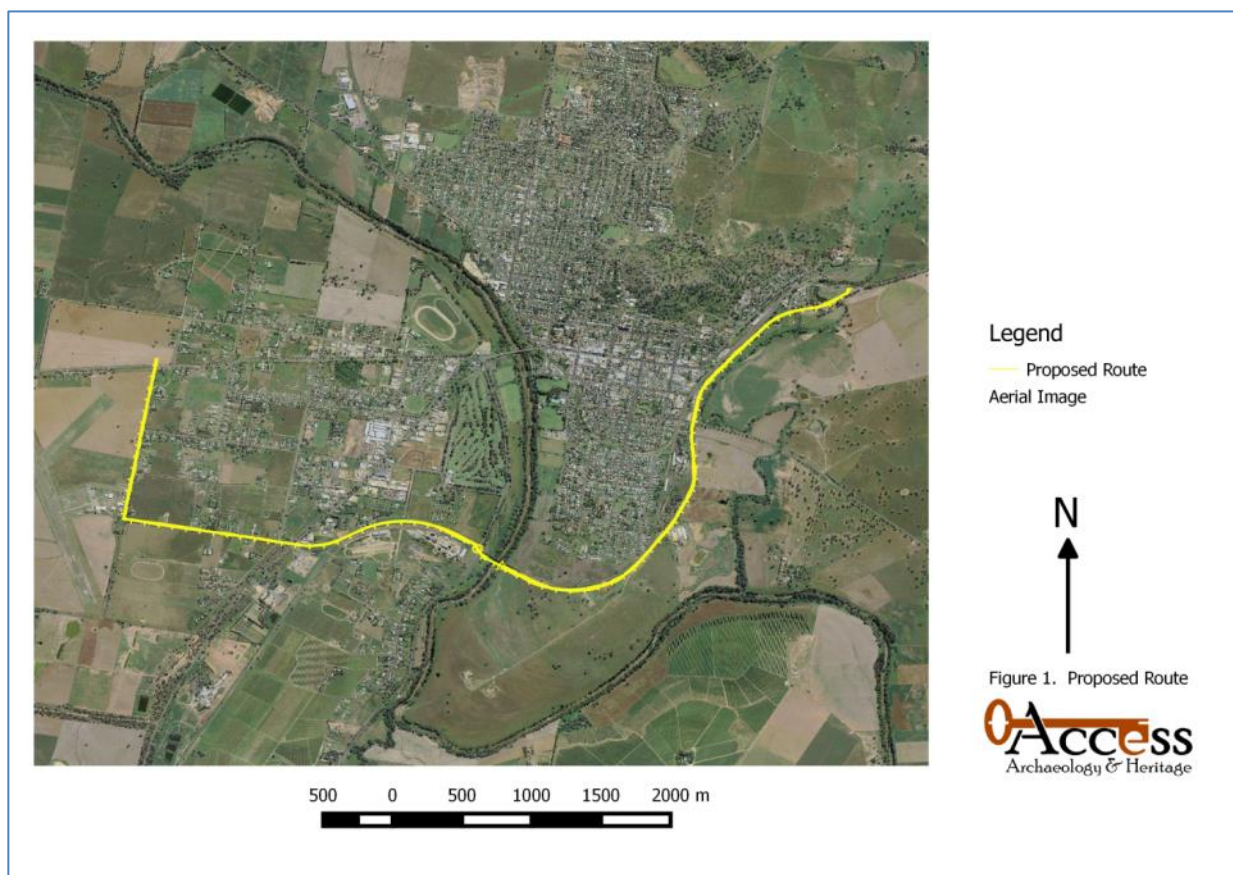
Figure 1. The Development Area

Cowra City Council is preparing a Review of Environmental Factors for a proposed Heavy vehicle By-pass of Cowra, to be known as the 'Southern Ring Road' (Figure 1). The road will be c.8.4km long, and follow approximately the southern outskirts of Cowra. From the west, it will leave Grenfell Road at Airport Road, following Airport road to Boundary Road. At the eastern end of Boundary Road it will follow Fishburn Street around to the Lachlan Valley Way, and cross the Lachlan River. From that point it will approximately follow Campbell Street to its intersection with the Mid Western Highway (Figure 1). Part of this alignment will be an upgrade and widening of the existing road, and part will be construction of a new carriageway, including a new river crossing.

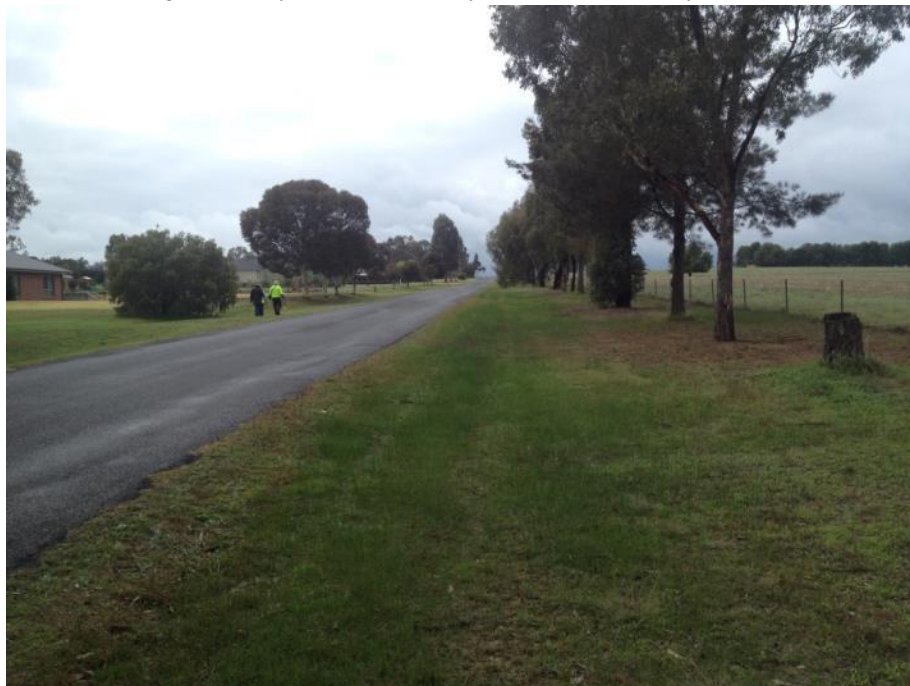
Plate 1. View South along Airport Road showing grassed verges with sporadic exposures

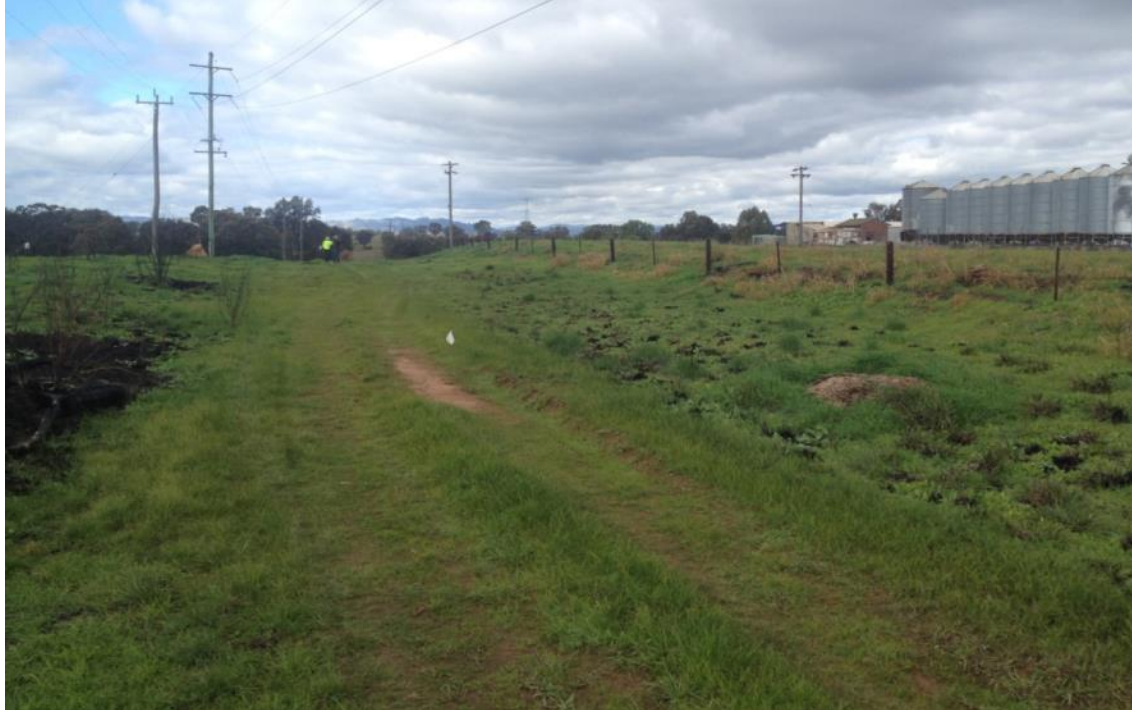
Plate 3. View east across artefact location (white stake flag) and PAD 1

This artefact was located in a small bare patch in a wheel rut on a track between the south of the Cowra mission and the rail line (Plate 3). The site is located on a high, relatively level terrace on the west side of the Lachlan River. The general area has undergone an indeterminate level of disturbance, but nonetheless contains considerable potential to exhibit a concentration of stone artefacts.

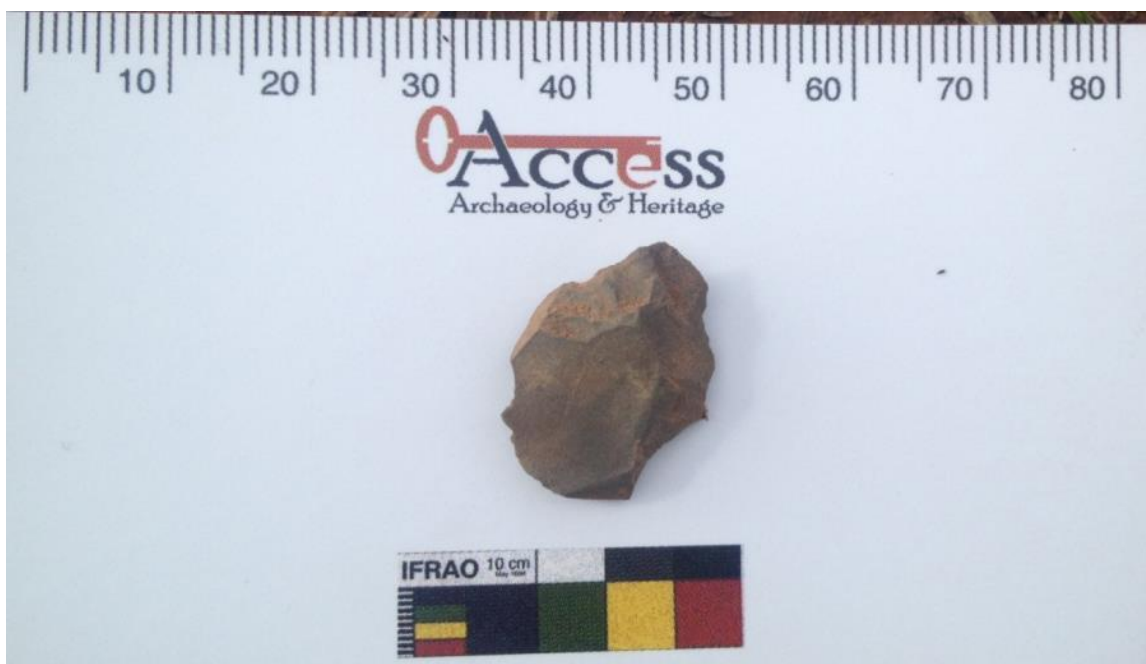
Plate 4. Artefact 1 – Dorsal Surface

Grey fine grained siliceous flake. 15mm x 15mm x 3mm. focal, unifacial platform, feather termination. 3 quadrant 1 scars.

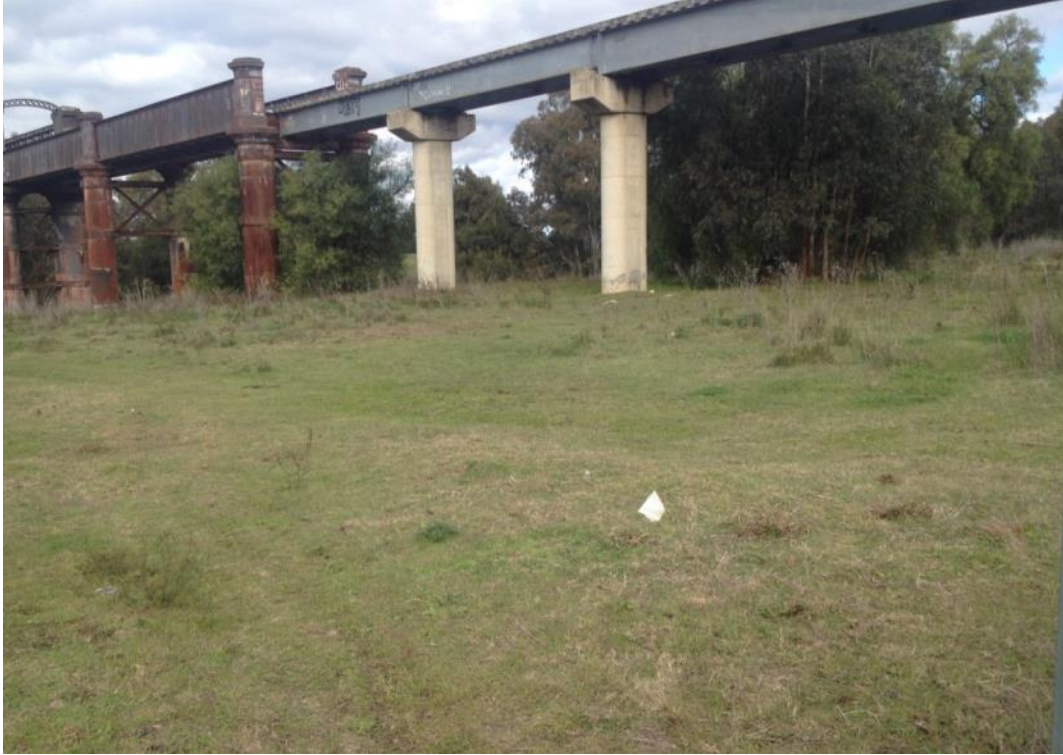
Plate 5. Artefact Location and north end of PAD 2

This artefact was located on the east side of the Lachlan Valley Way, and the north side of the rail bridge, in the alignment of a proposed roundabout in the road design. The locality is a river terrace immediately adjacent to the Lachlan River to the east. The locality is also that identified as a 20<sup>th</sup> century collection of huts called 'Ryans Place' (Kabaila 1996: 31-33) (Figure 4).

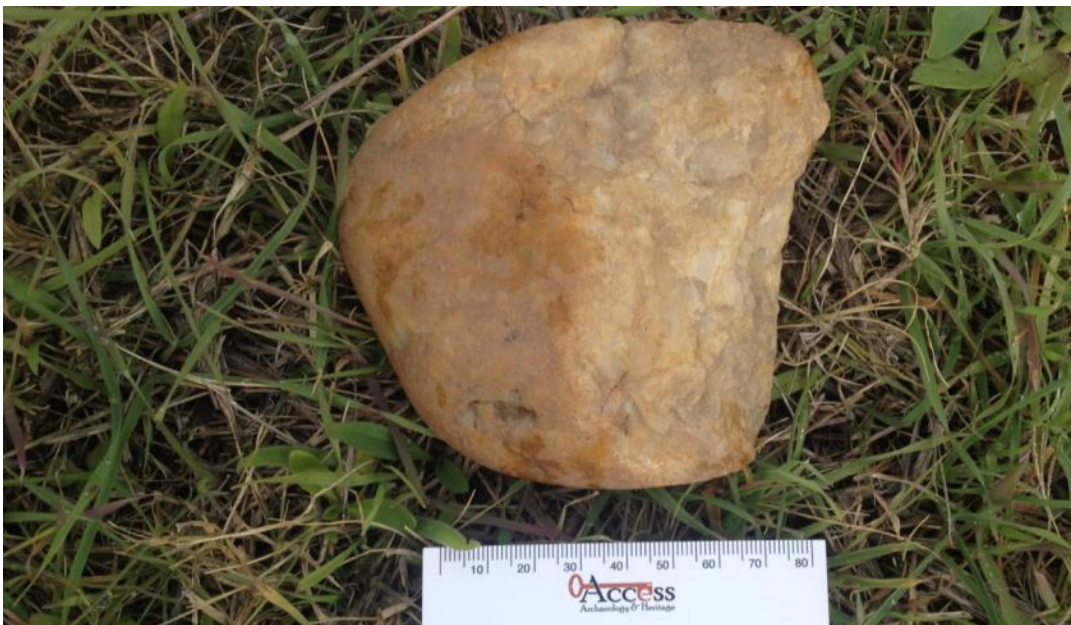
Plate 6. Artefact 2.

Cream quartz core. 50mm x 110mm x 100mm. 8 flake scars from 2 alternate platforms, 70% pebble cortex. While technologically a 'core', typologically would be classified as a chopper made on a pebble.

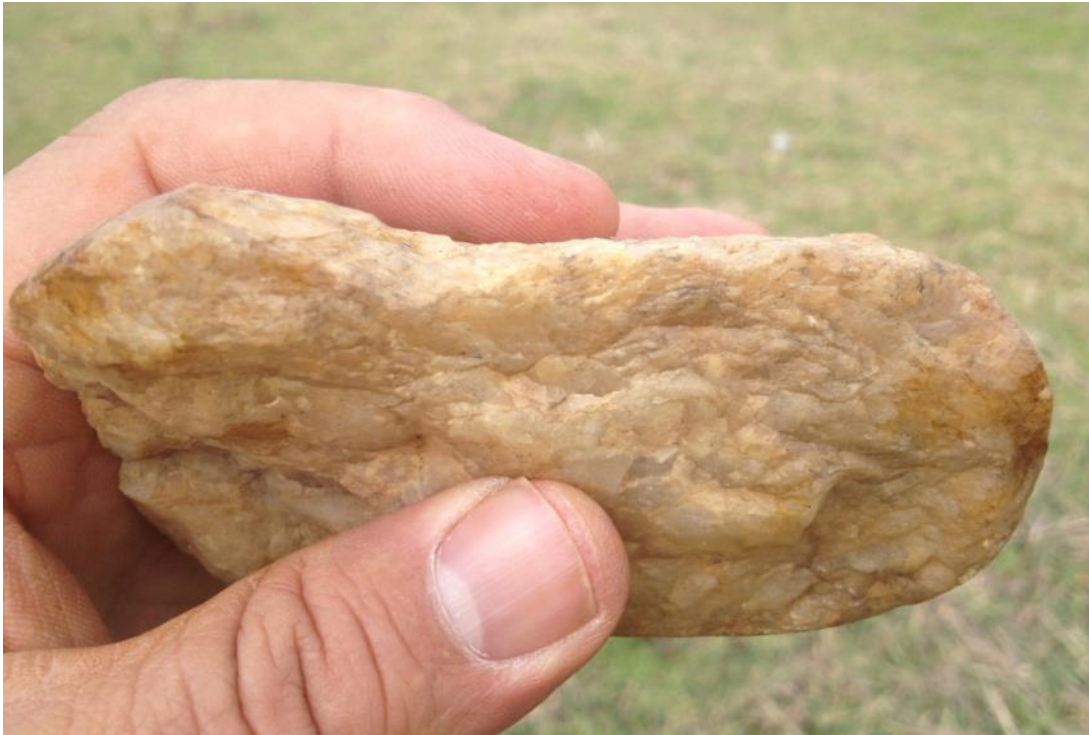
**Plate 7. Artefact 2 – flaked edge photo A.**

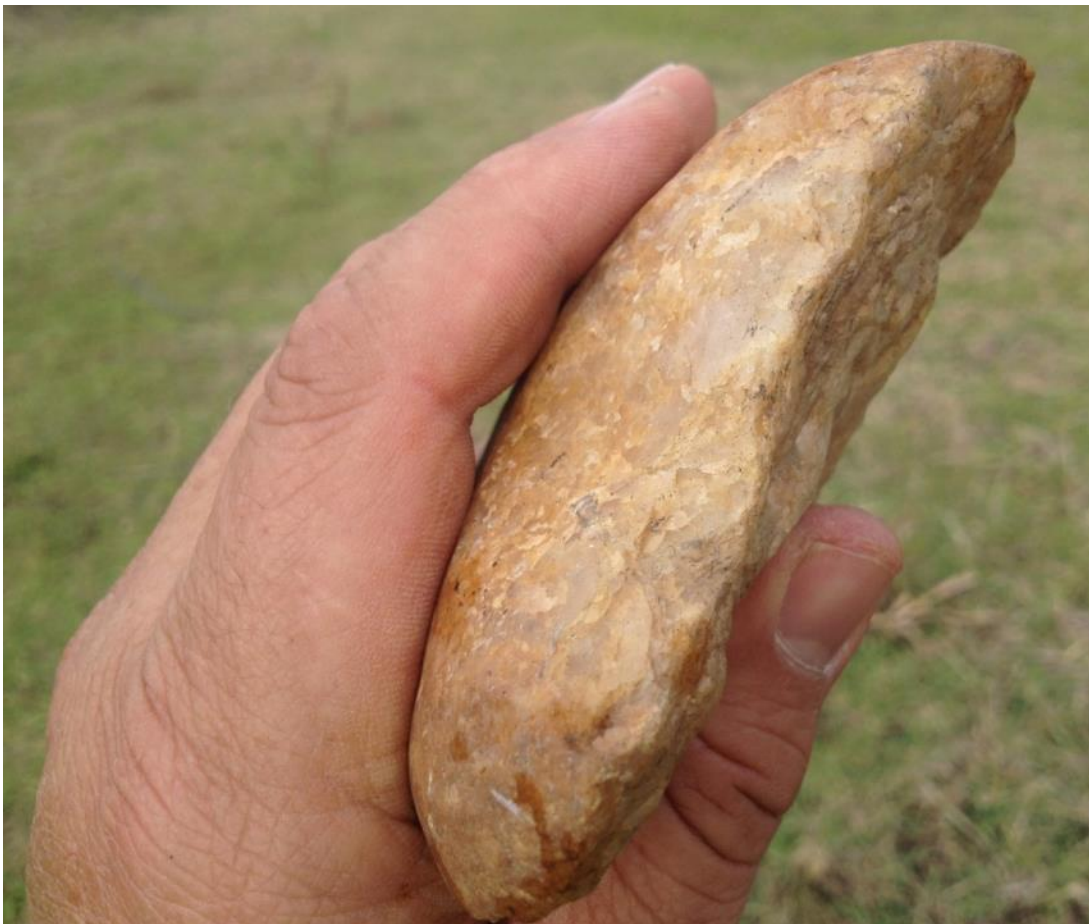
**Plate 8. Artefact 2 – flaked edge photo B.**

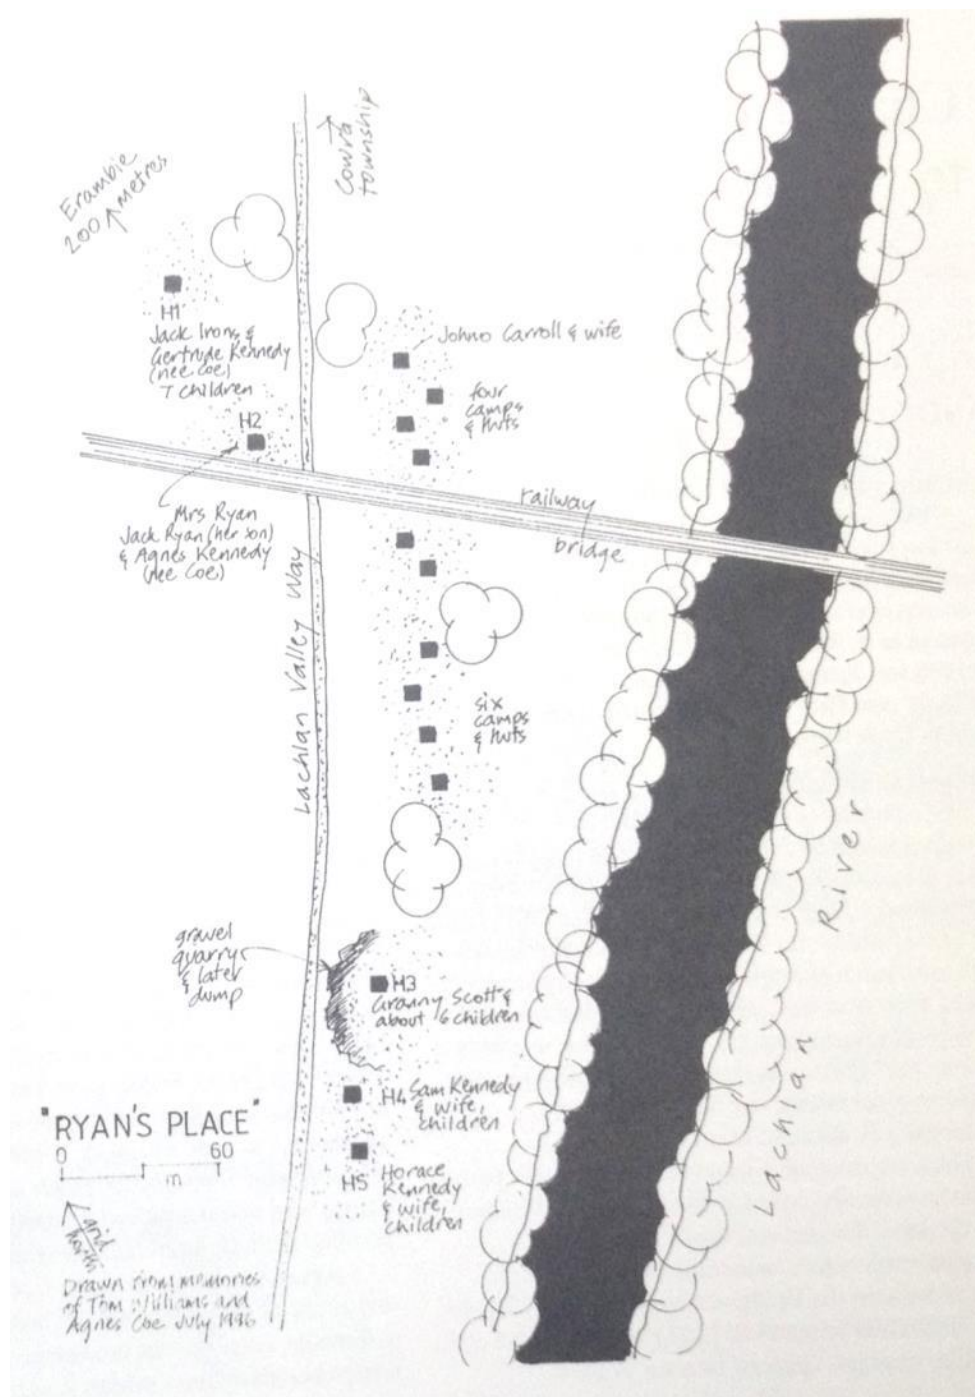
Figure 4. 'Ryan's Place'. Reproduced from Kabaila 1996:33

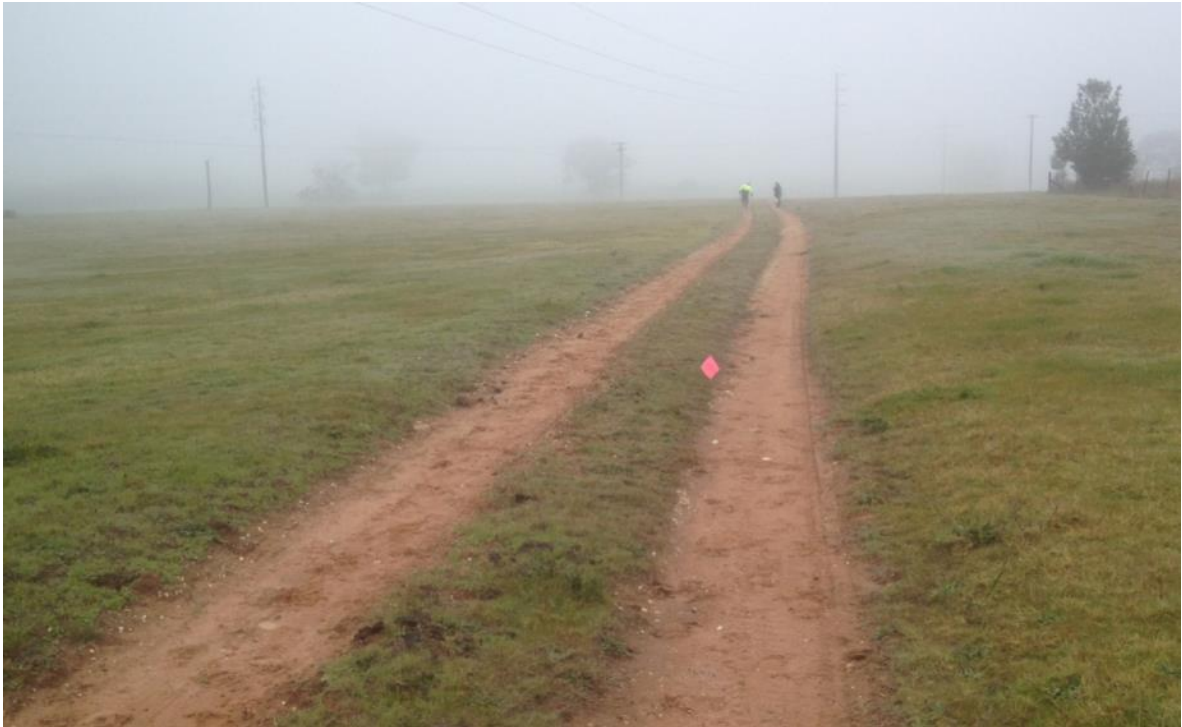
**Plate 9. Looking south across PAD 6 at location of Artefact 3**

Artefact 3 was located on a farm track to the south west of a disused wool scour facility, and to the east of the railway corridor. In this location the track crosses an elevated, distinct level spur consisting of alluvial gravels and coarse sand. The crest of this spur is identified in this study as PAD 6.

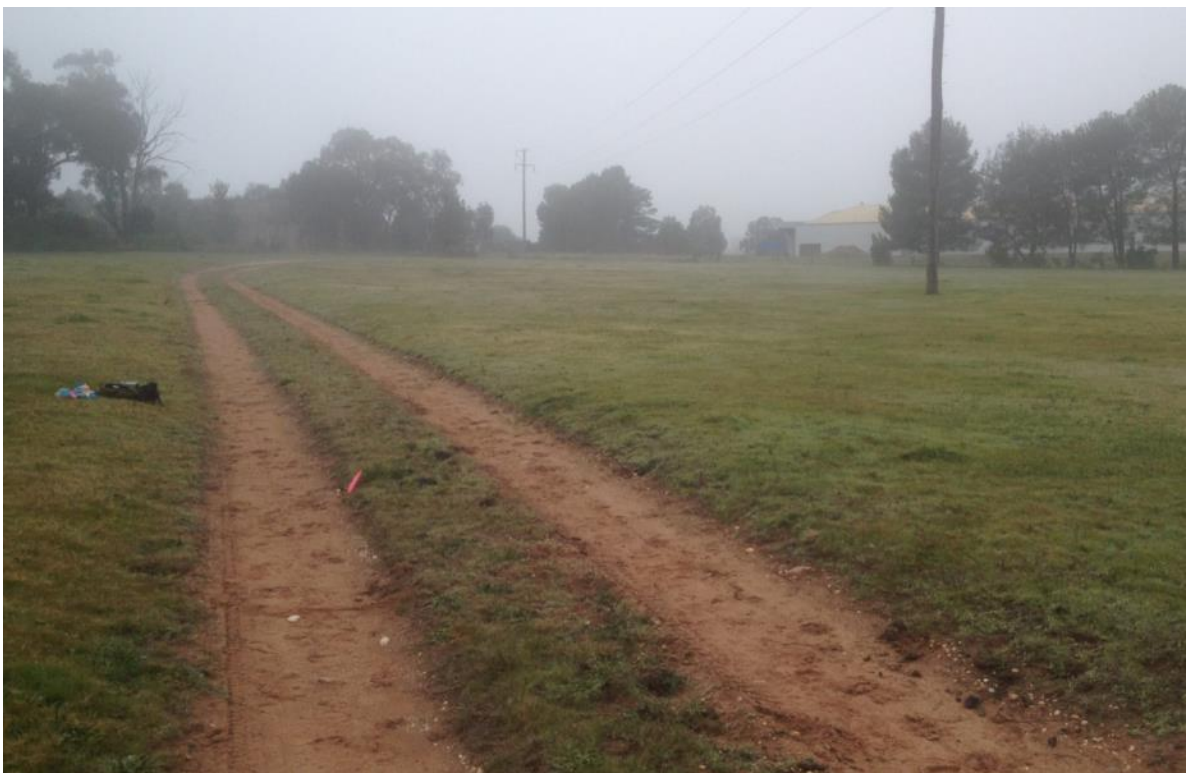
**Plate 10. Looking north across PAD 6 at location of Artefact 3.  
Note disused wool scour shed in background**

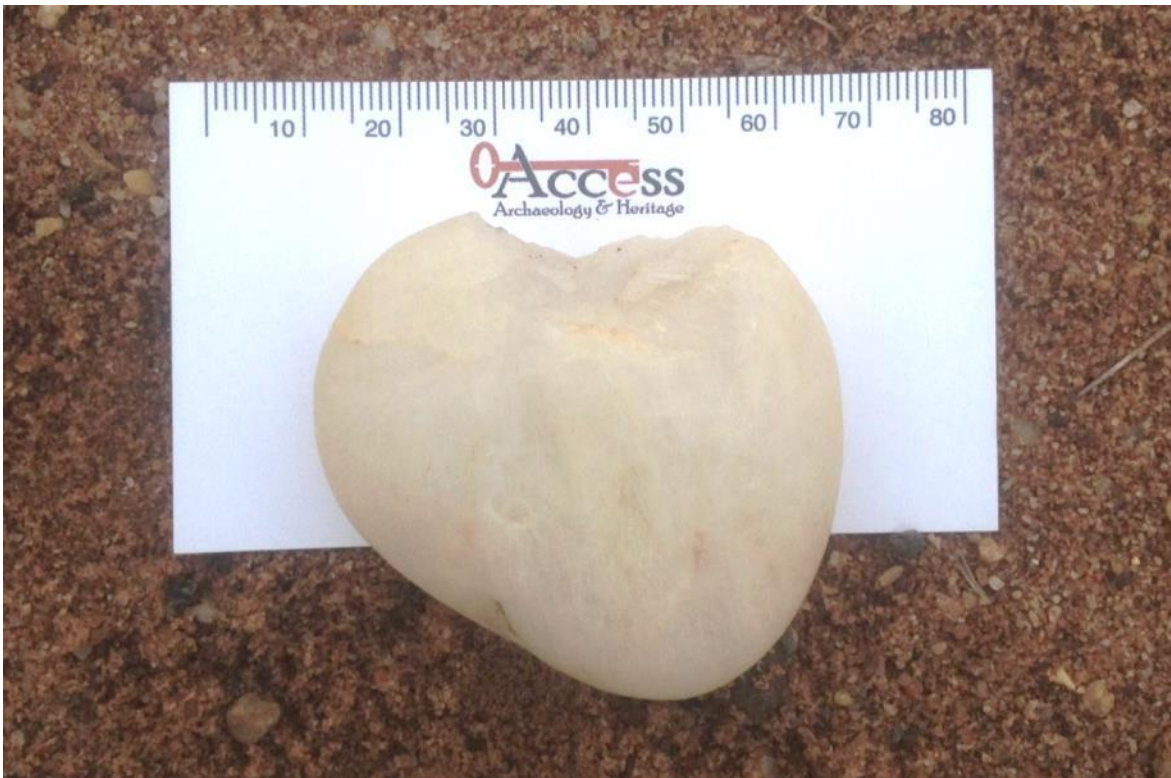
Plate 11. Artefact 3.

White quartz core. 12mm x 53mm x 45mm. 1 flake scars from 1 cortical platform, 90% pebble cortex.

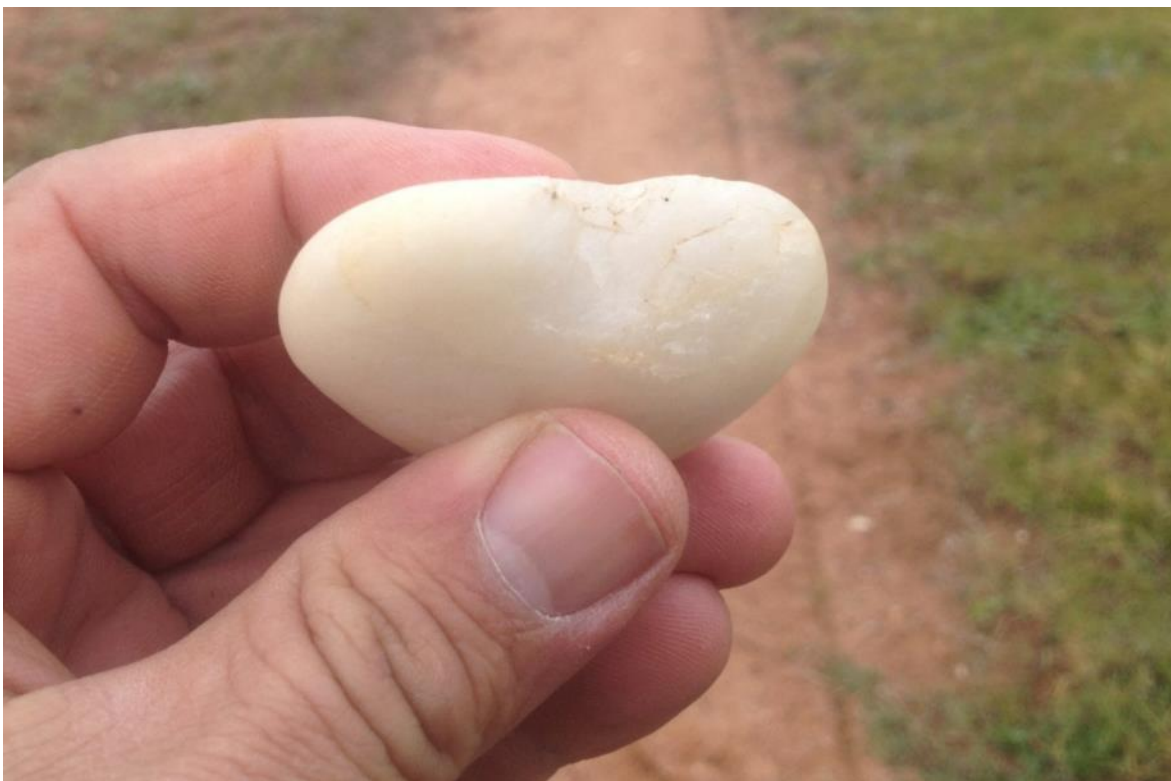
Plate 12. Artefact 3 conchoidal scar

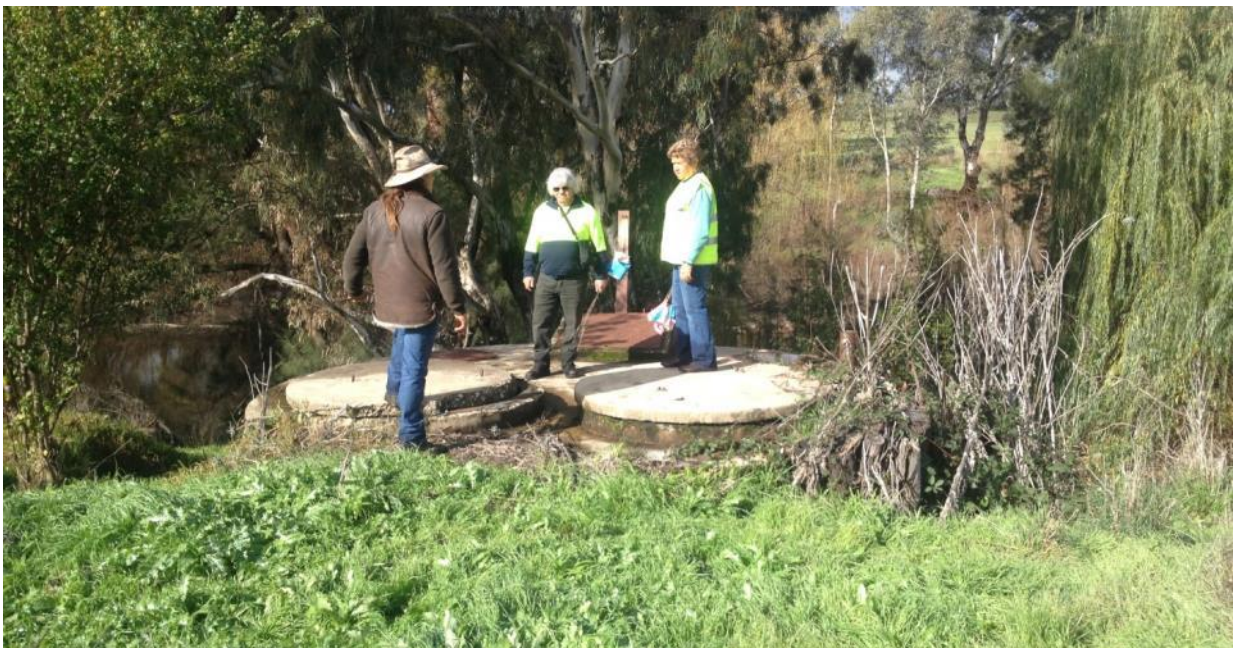
**Plate 13. Concrete tank associated with Cowra power station**

This feature is a large, round concrete tank set into the western bank of the Lachlan River, on the south side of the rail bridge. To the north of the tank is a drain running back into the Lachlan River. Neville Williams and Esther Cutmore considered this feature to be the pump station for water to be supplied to the power station. Mr Williams relayed the story that in the mid 20<sup>th</sup> century, after the water as used in the power station the drain (or a drain) returned hot water to the river, and children would swim in the warm water down stream as it mixed with the cold water of the river.

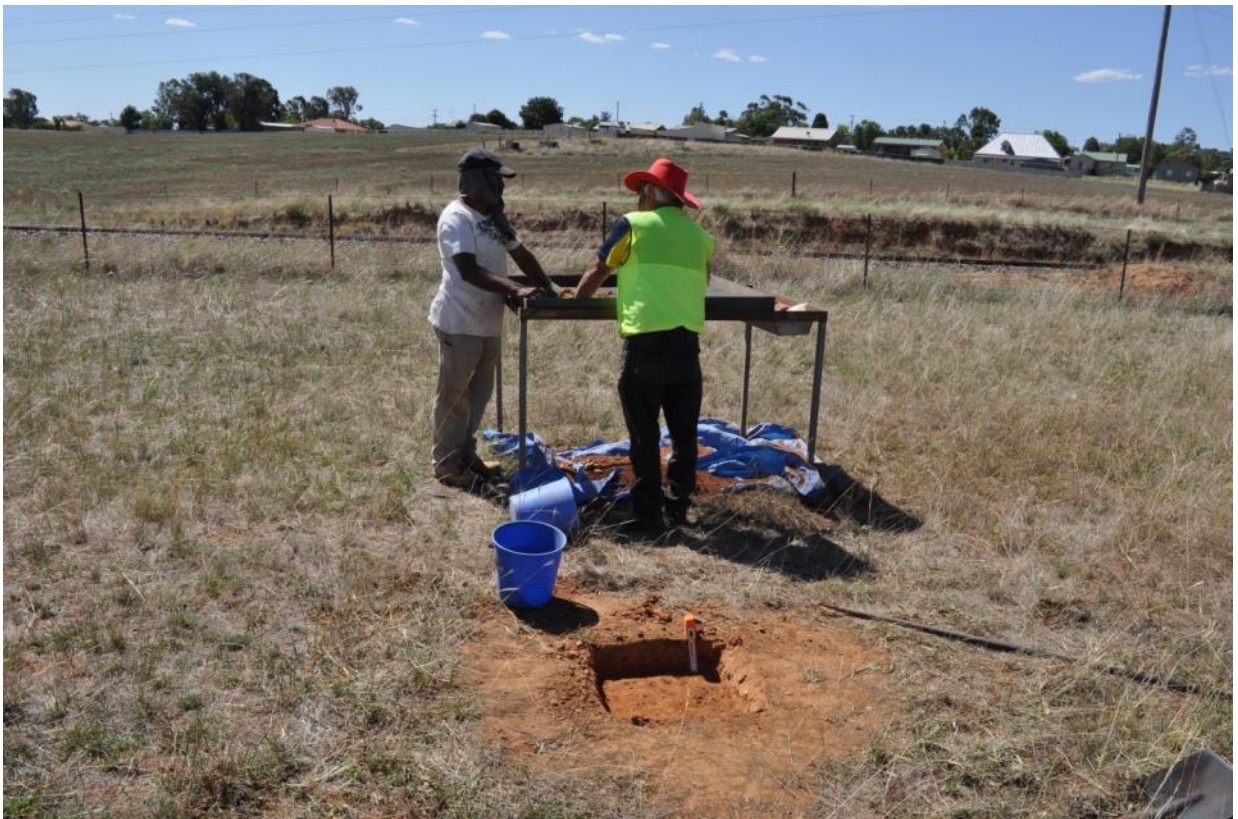
**Plate 14. Screening excavated deposit at a test excavation location**

The physical investigation of the sites entailed the excavation of a series of 0.5m x 0.5m test pits, 5m apart in linear transects. The transects were sited within the proposed development corridor where possible. Excavation was undertaken by shovel with assistance of a crow bar in compact deposit and proceeded using 50mm spits, or as close as could be managed in difficult deposit. Excavated material was screened through a 5mm mesh on a 1.2m x 1m screen table and residue was sorted on the screen table. Cultural material (Aboriginal or European) retained for later recording.

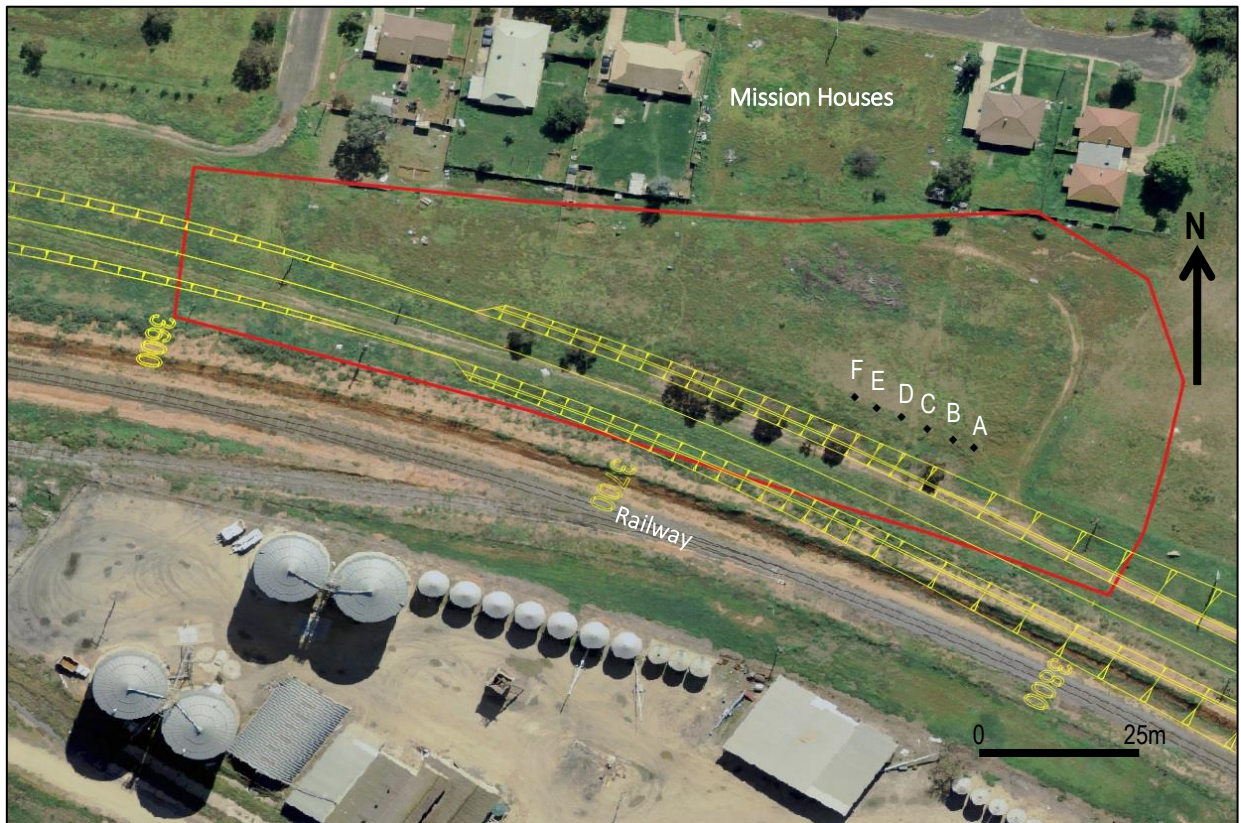
Figure 5. Test pits within PAD 1.

The investigation transect comprised six test pits spaced five metres apart in a single transect (Figure 5, Plate 15).

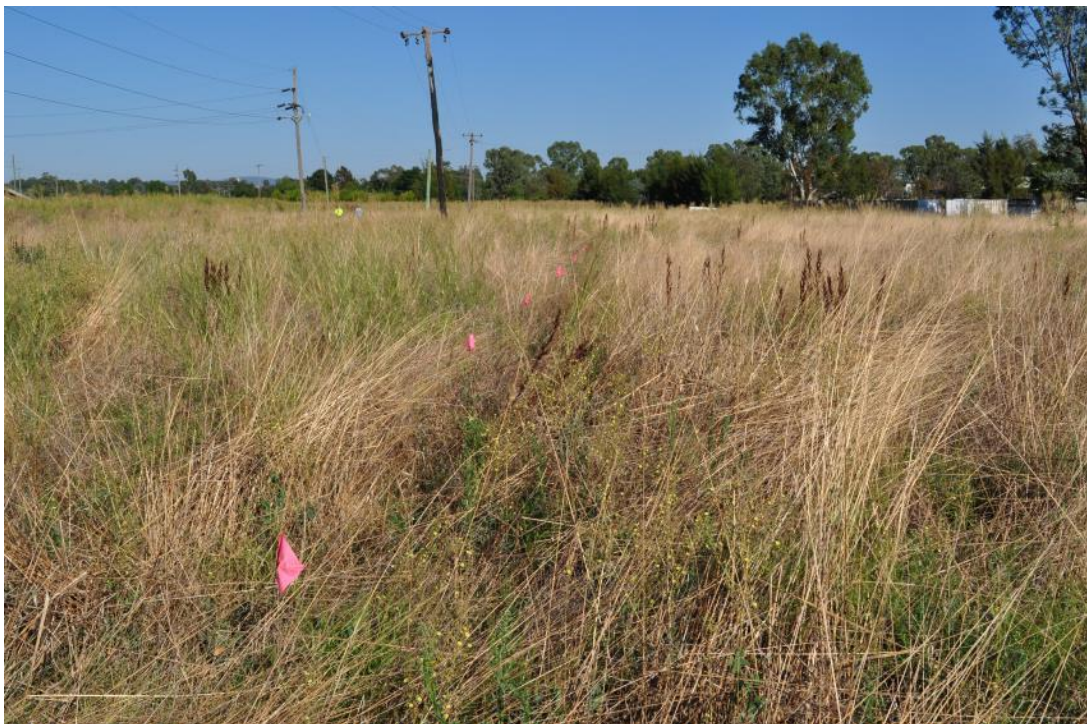
Plate 15. View north west along PAD 1/Transect 1. Pink flags indicate probe locations, Probe A nearest to viewer.

Excavation at PAD 1 revealed a topsoil profile approximately 400mm deep, consisting of loose tan fine sand with humic material to ~120mm and orangey tan fine sand below that to 400mm and an interface with orange clay. Aboriginal cultural material, in the form of stone artefacts, was found in three of the probes excavated at PAD 1.

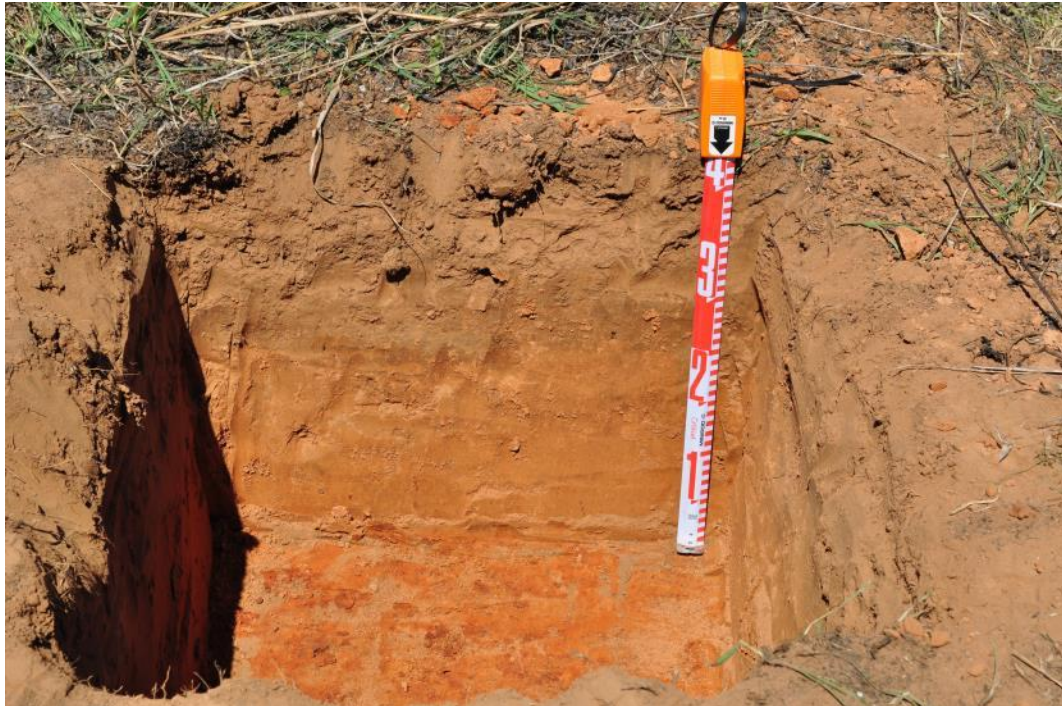
**Plate 16. Representative soil profile, PAD 1**

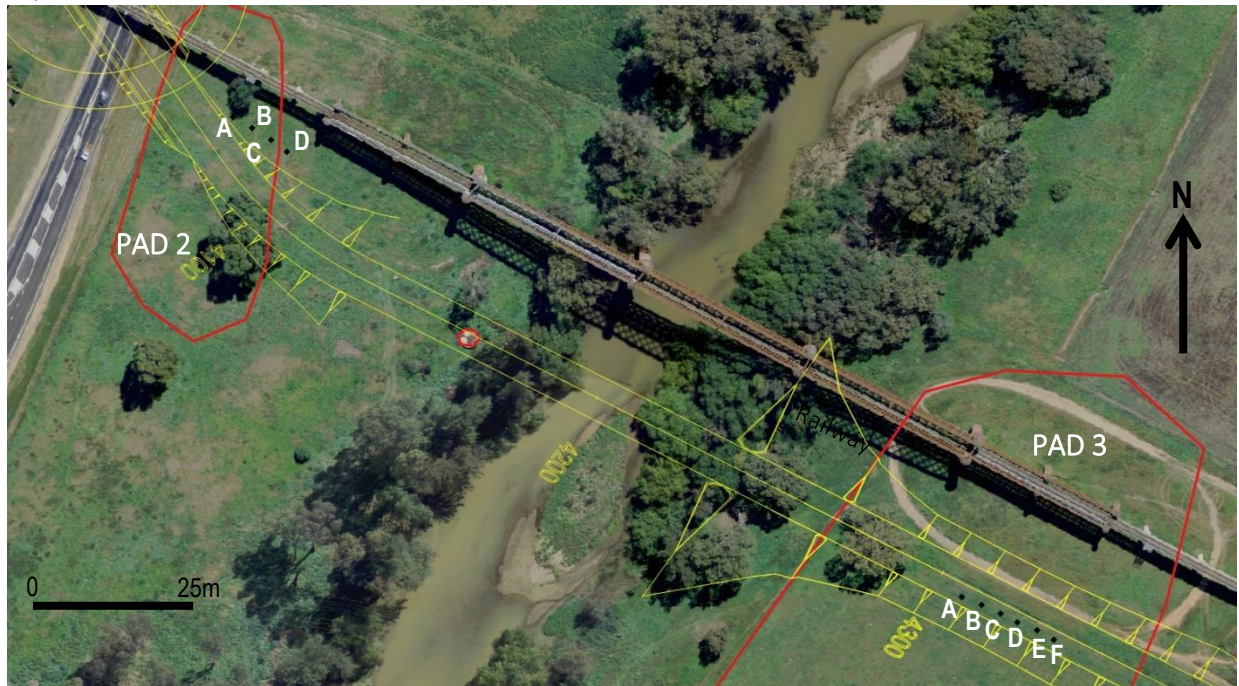
Figure 6. Test pits at PAD 2

PAD 2 is a river terrace on the western side of the Lachlan River. The terrace runs parallel to the river for several kilometres to the north and south of the location of the proposed bypass. At the location of the proposed bypass The investigation transect comprised four test pits spaced five metres apart in a single transect (Figure 6, Plate 16).

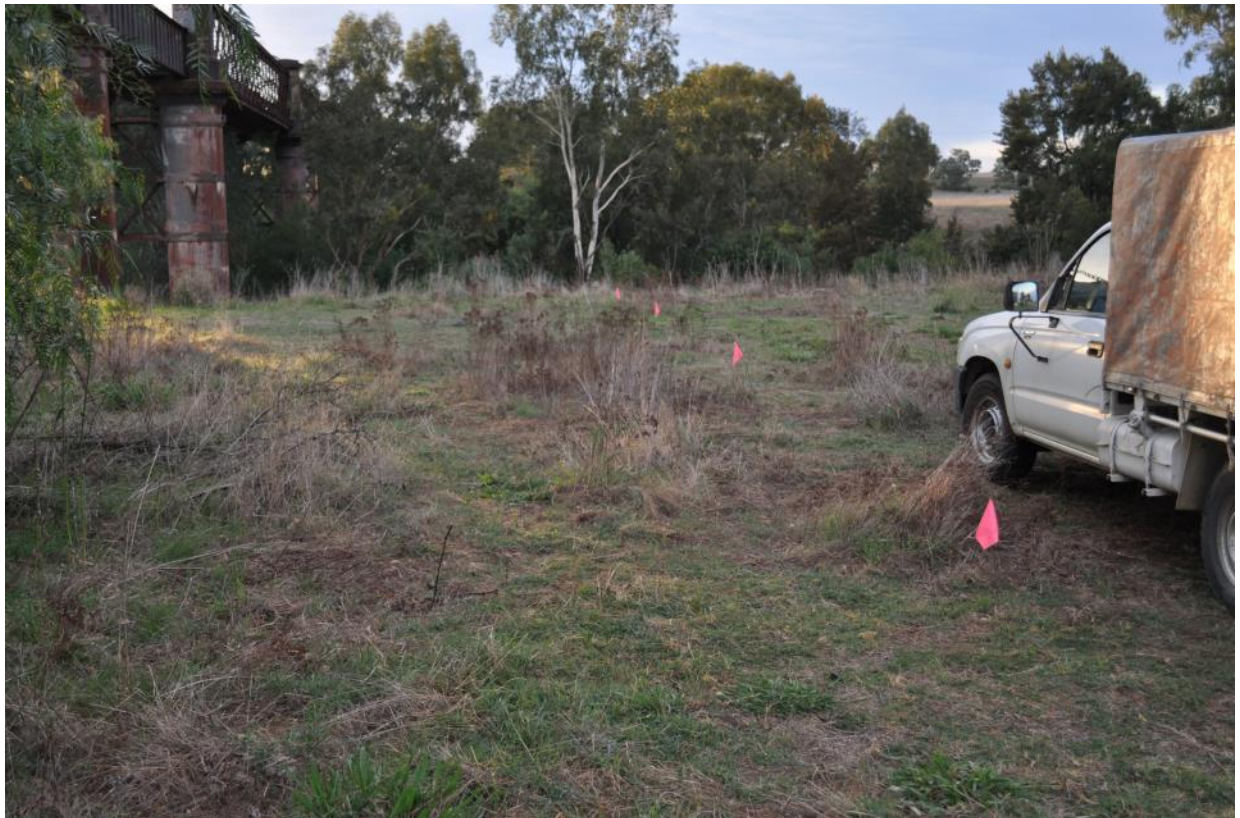
Plate 16 View east along PAD 2/Transect 1. Pink flags indicate probe locations, Probe A nearest to viewer.

The soil profile at PAD 2 was predictably deep, being in a zone of alluvial deposition. Probe depth varied between 620mm and 750mm and the deposit was very compact. The top layer of the probes was a dense layer of blue metal, being the result of railway blue metal falling from above. Under this rocky surface layer, the deposit was a mid brown fine silty sand (Plate 17). Occasional water rolled pebbles were encountered.

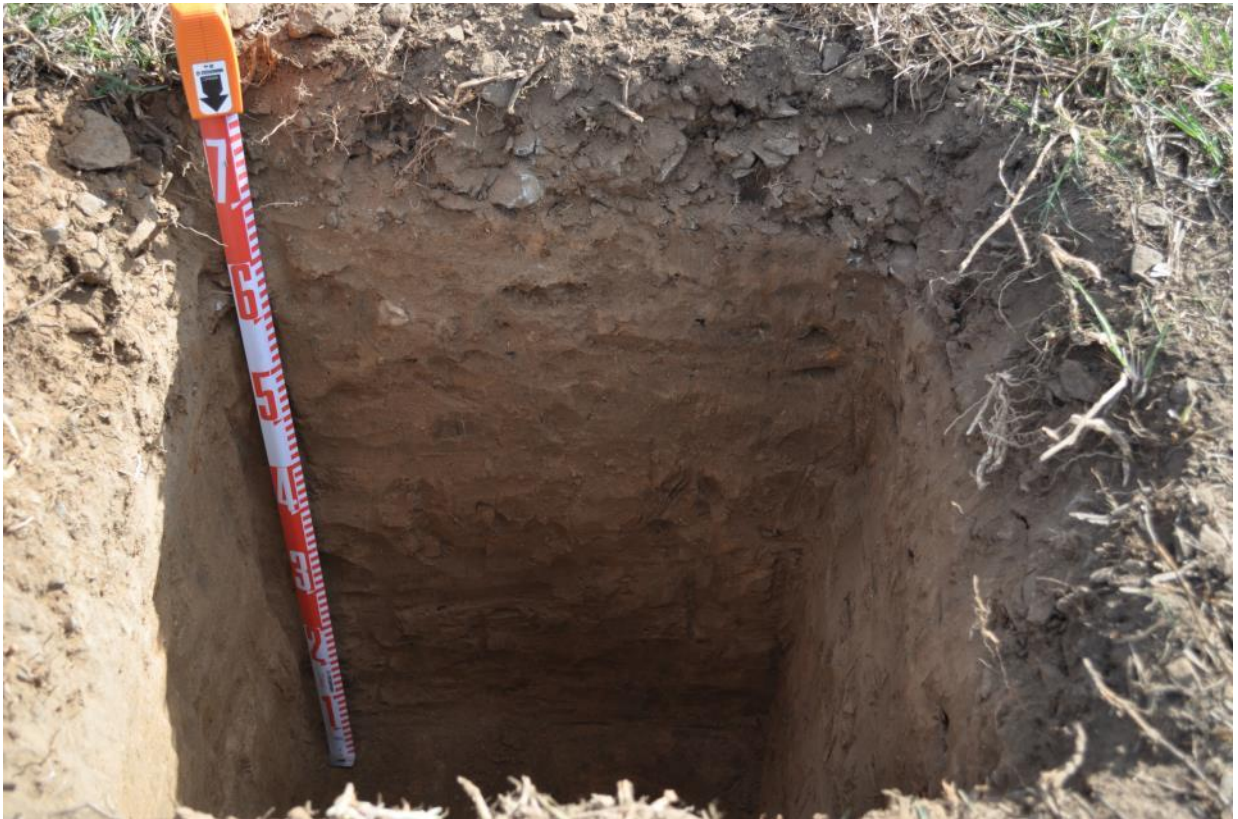
**Plate 17. Pad 2 Transect 1 Probe A: Soil profile at PAD 2.**

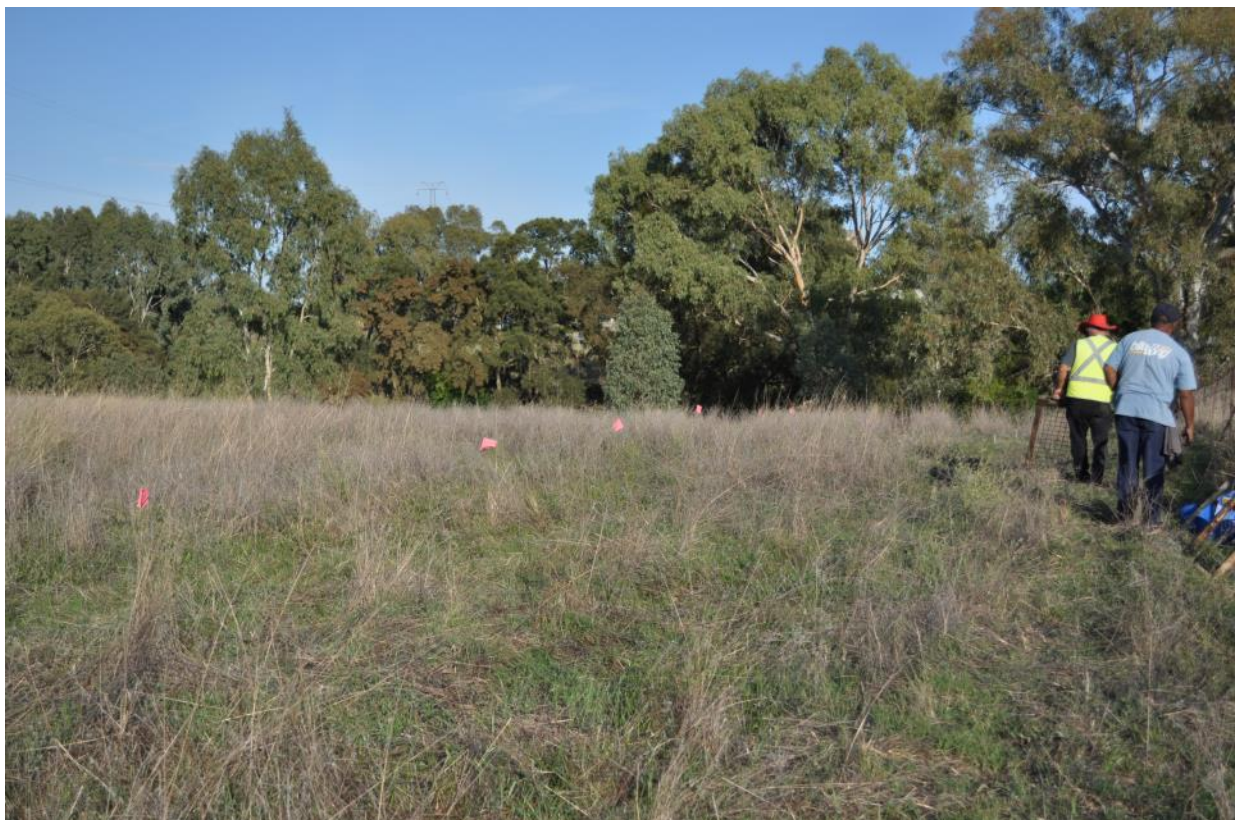
Plate 18. View East along transect. Probe F closest to viewer.

The investigation transect comprised six test pits spaced five metres apart in a single transect (Figure 7, Plate 18).

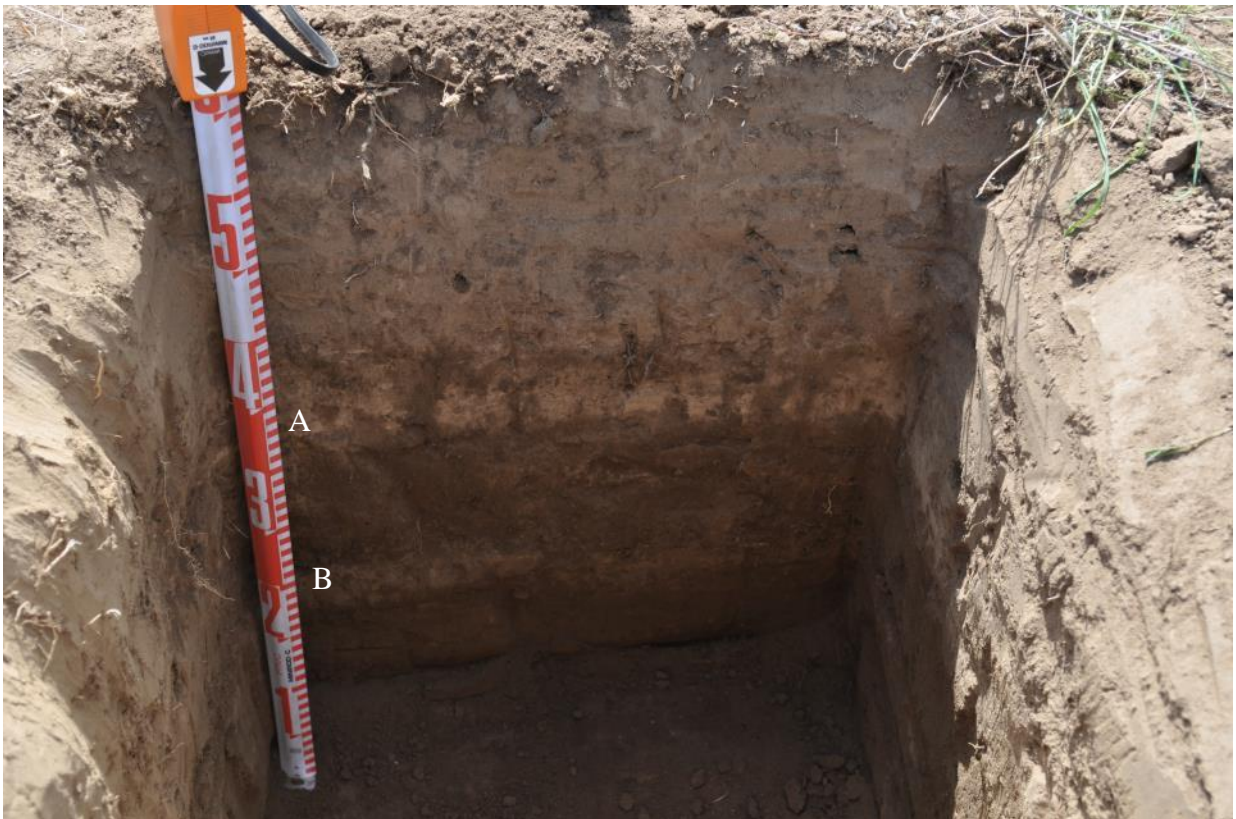
Plate 19. Representative soil profile, PAD 3. Note more damp deposit at depth, and evidence of prior surfaces (A and B)

The deposit at this location was a moderately compact silty sand. Its upper levels were grey silty sand. Below this the texture remained the same but the colour was noted to change to an orangey brown one. In several probes there appeared two narrow bands obviously more compact and lighter in colour (plate 19). The texture of the deposit was typical of levee deposits.
