## **ABORIGINAL CULTURAL HERITAGE ASSESSMENT**

## Cowra Heavy Vehicle By-Pass

Cowra, NSW.

Doug Williams  
May 2016

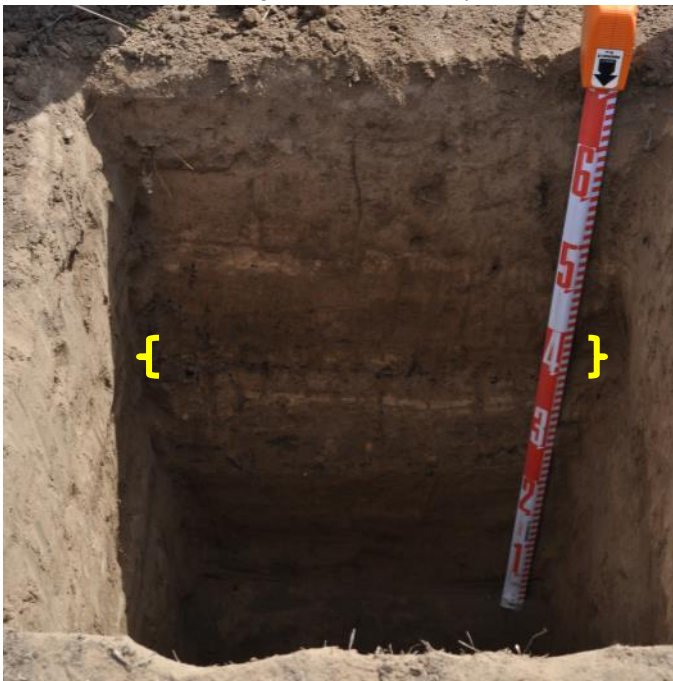
Plate 20. PAD 3/Transect 1/Probe E/Spit 5.  
Parentheses show location of glass concentration.

There were no stone artefacts recovered from any of the probes at PAD 3. However, of interest was one artefact we interpret as a glass scraping/cutting implement. The artefact was found at level 5 of probe E (~200-250mm below surface). The artefact was made on the side of a bottle and has damage consistent with use as a scraping or cutting implement as opposed to treadage or plough damage. It was found as part of a group of seven glass pieces of the same glass, non-conjoining and as they all exhibit the same patina they broke in antiquity at the same time. The depth of the glass pieces broadly corresponded with the location of a charcoal concentration and

a prior levee surface, both being visible in the section shown in Plate 20. The correspondence of these three features in the soil profile strongly suggest an *insitu* cultural event at the time this level was exposed as the levee surface, such event being during the early period of European settlement. While it is possible this represents European activity, the fracture pattern on the glass artefact is inconsistent with European glass use but fully consistent with Aboriginal glass use.

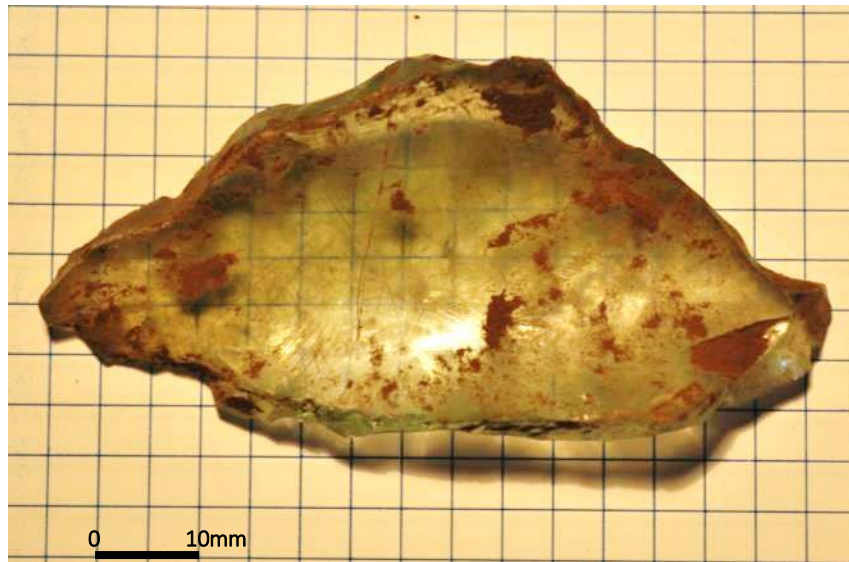
Plate 21. Glass Scraper

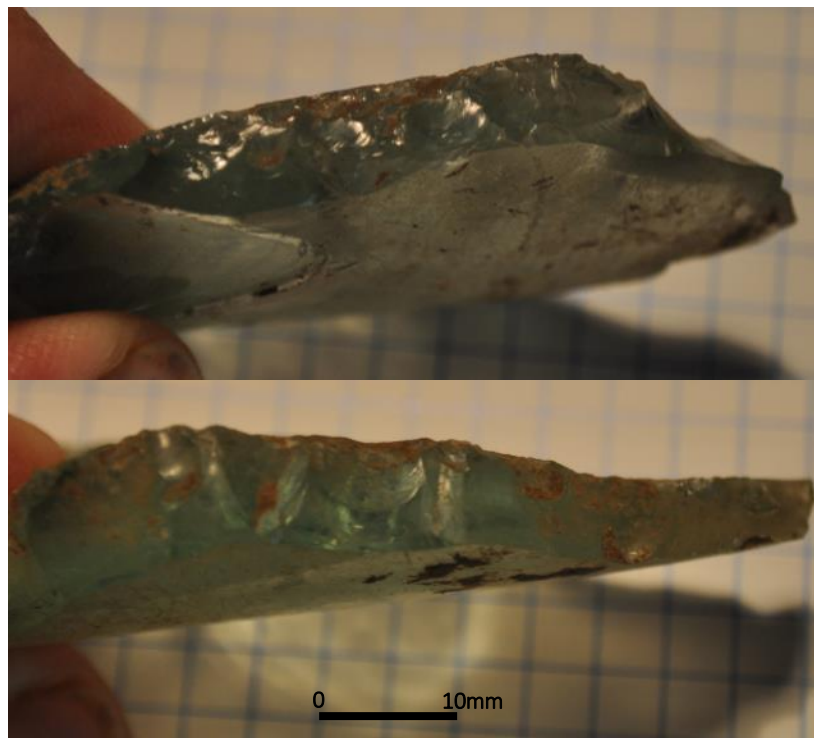
Plate 22. Utilised/damaged edges

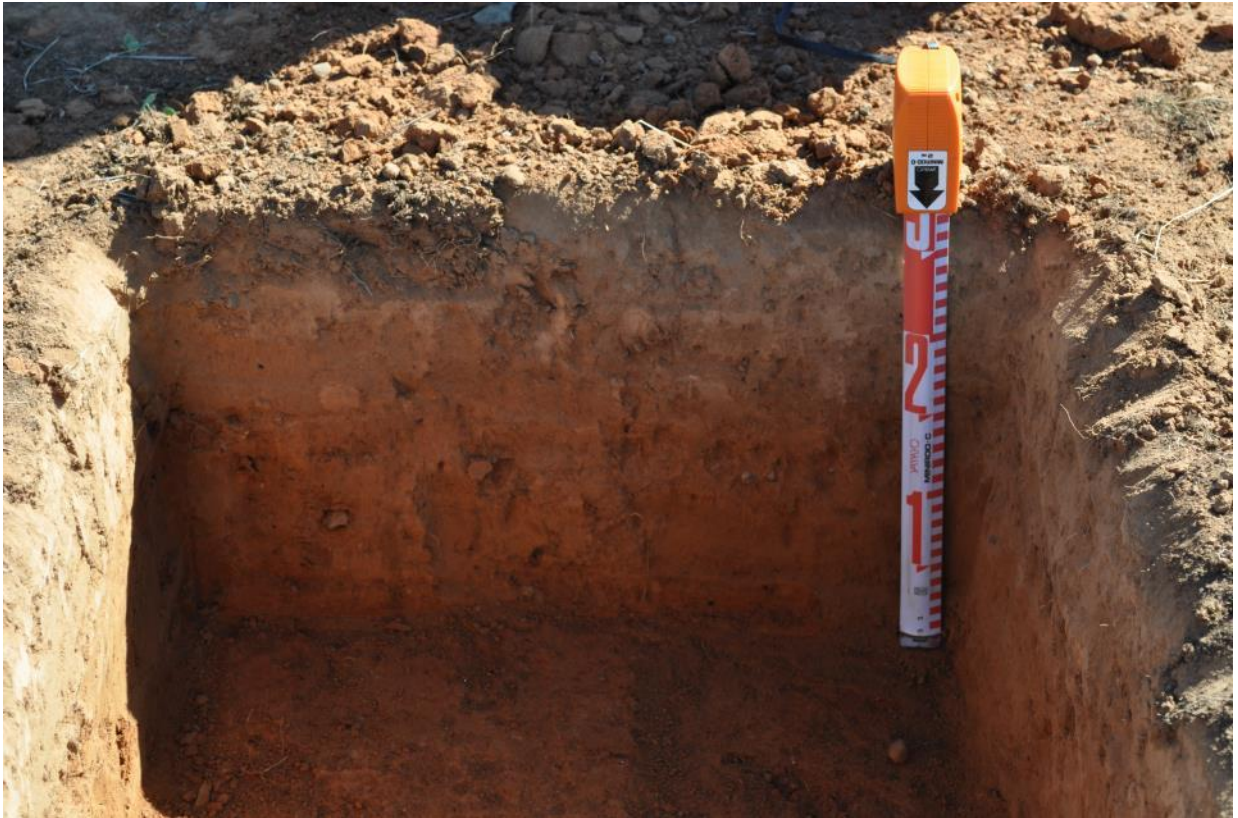
Plate 24. General soil profile of PAD 4

The soil of the test area consisted of moderately compact orange-brown silty sand. The upper levels were largely devoid of gravels, with rolled gravels increasing with depth. Overall the soil profile above clay was shallow, averaging 250-300mm.

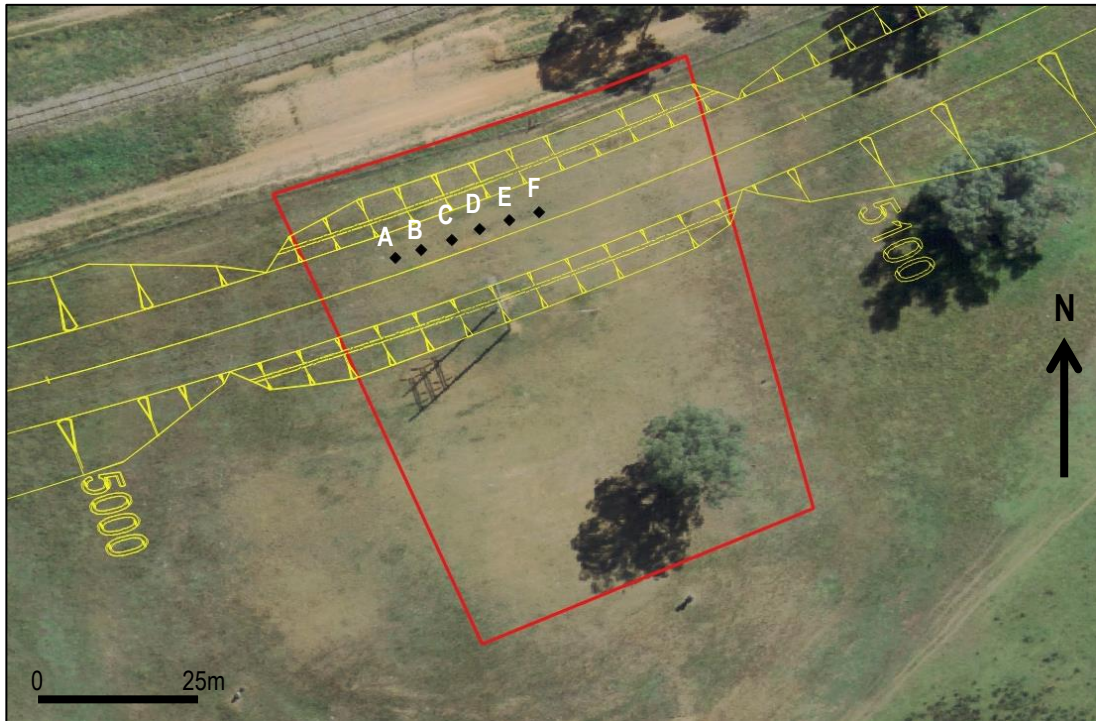
Figure 9. Test pits at PAD 5

PAD 5 is the crest of a knoll ~450m east of PAD 4 and the edge of the floodplain. It was selected for testing as a PAD as it is a raised area of level ground adjacent to a watercourse which is intermittently wide and swampy, as well as being relatively close to the Lachlan River corridor. The investigation transect comprised six test pits spaced five metres apart in a single transect (Figure 9, Plate 25). The soil of the test area consisted of very compact gravel rich orange-brown silty sand. Overall the soil profile above clay was shallow, averaging 150-200mm. **No cultural material was found in the test pits of PAD 5.**

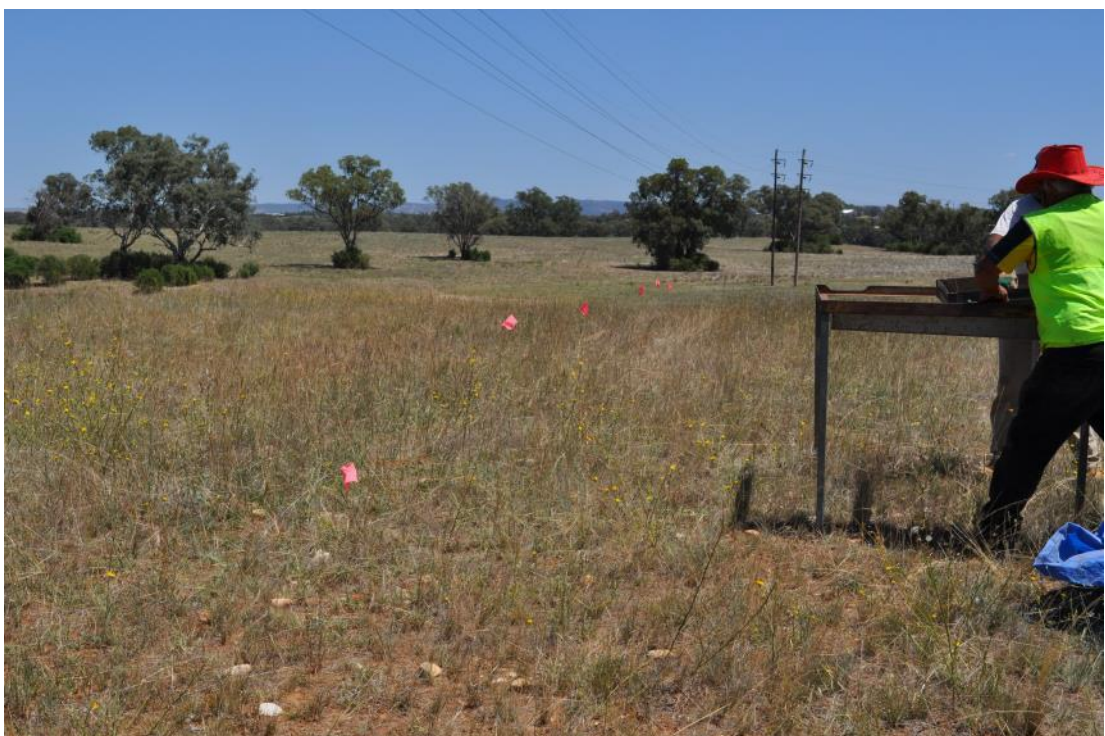
Plate 25. View west across PAD 5, Transect 1. Probe F is closest to viewer.

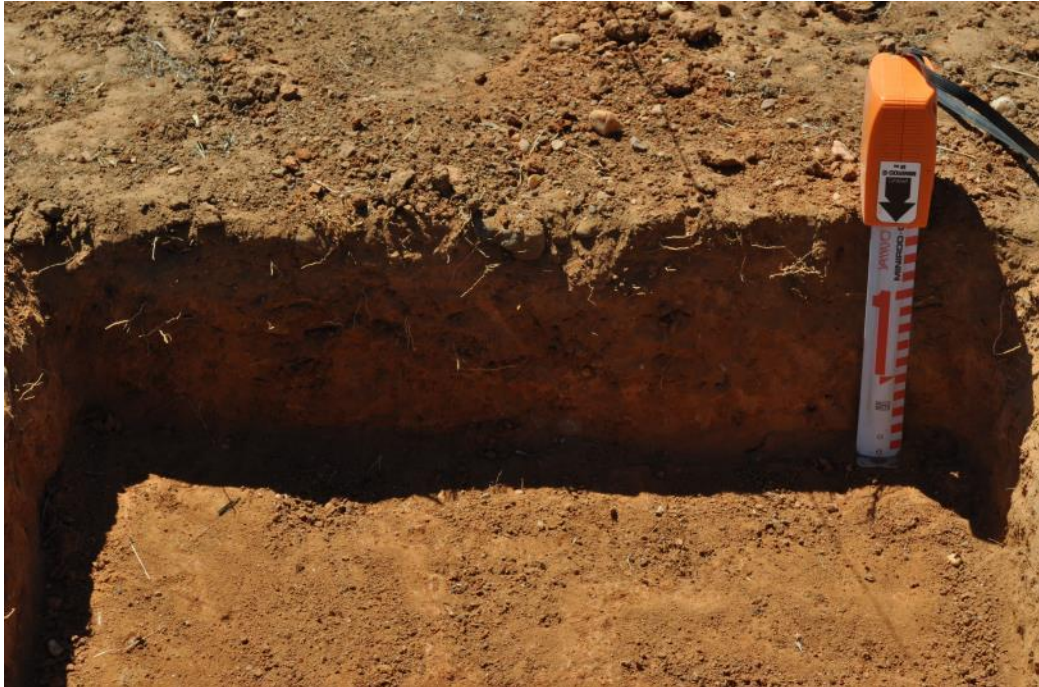
Plate 26. Soil profile, PAD 5.

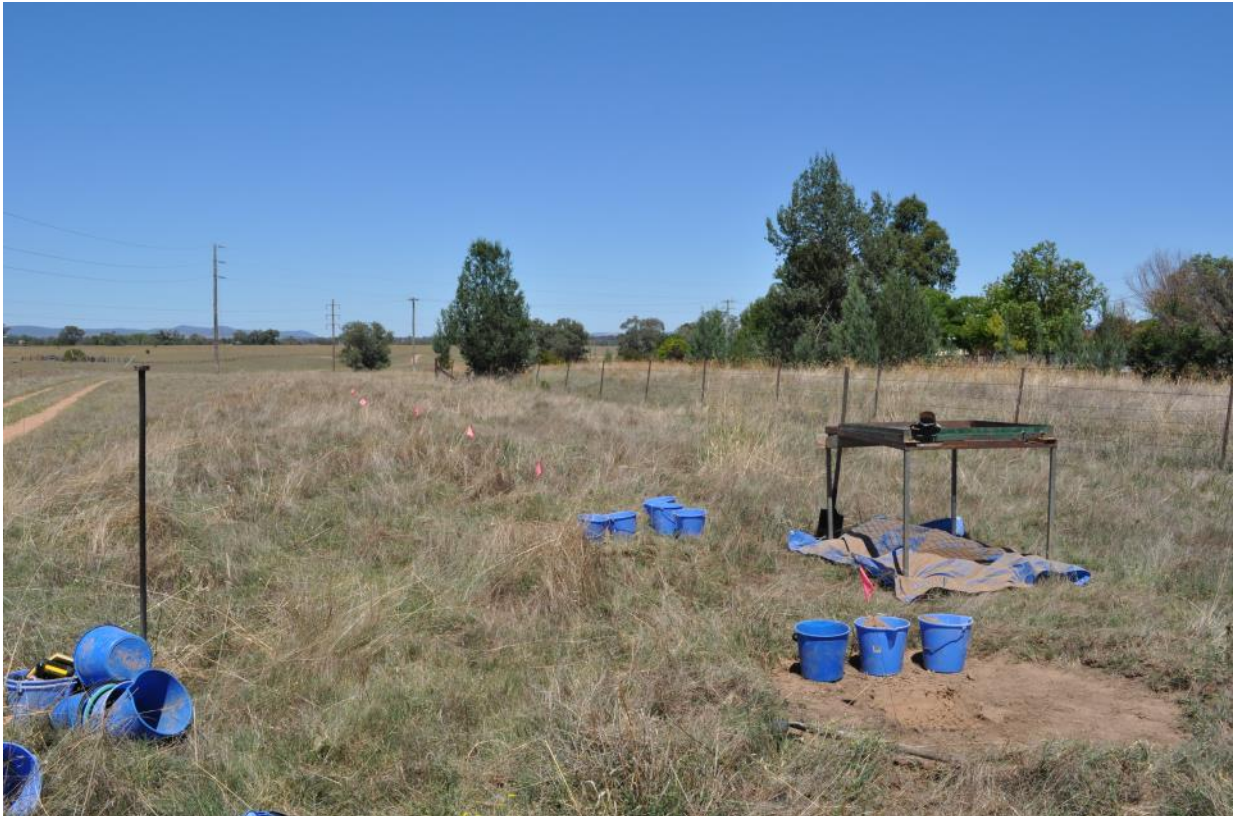
Plate 28. View south across PAD 6/Transect 2. Probe A has been excavated and backfilled in lower right foreground

The area of PAD 6 crossed by the proposed bypass route is ~250m long, and for this reason two transects of probes were excavated. Transect 1 was the more northerly and consisted of six test pits spaced five metres apart (Figures 10,11, Plate 27). Transect 2 was the more southerly of the two and consisted of five test pits spaced five metres apart. (Figures 10,11, Plate 28).

The soil profile encountered at PAD 6 was silty sand between 300mm and 700mm deep, over an orange sandy clay base. The upper levels were a grey to dark grey humic silty sand, underlain by tan/beige silty sand. Pelletal gravels increased at ~400mm. **No cultural material was found in Transects 1 or 2 of PAD 6.**

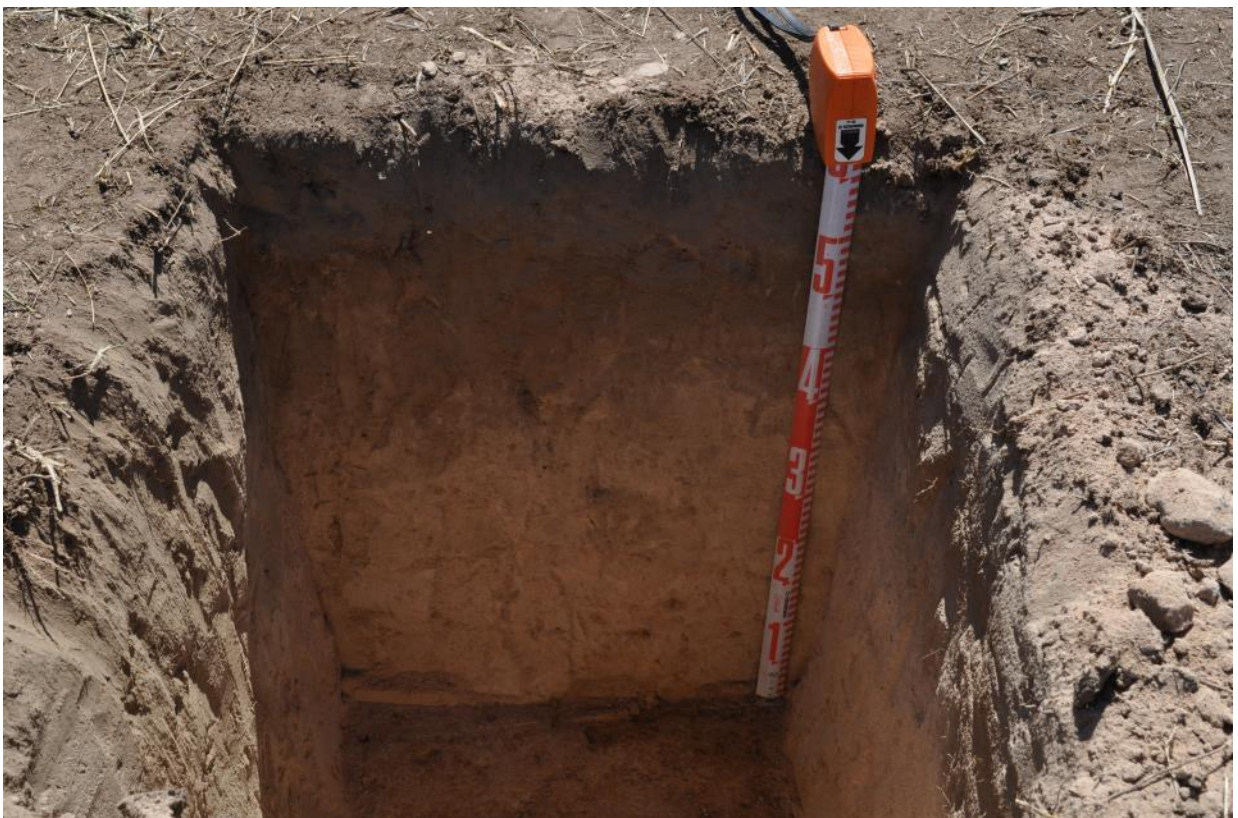
Plate 29. General soil profile at PAD 6

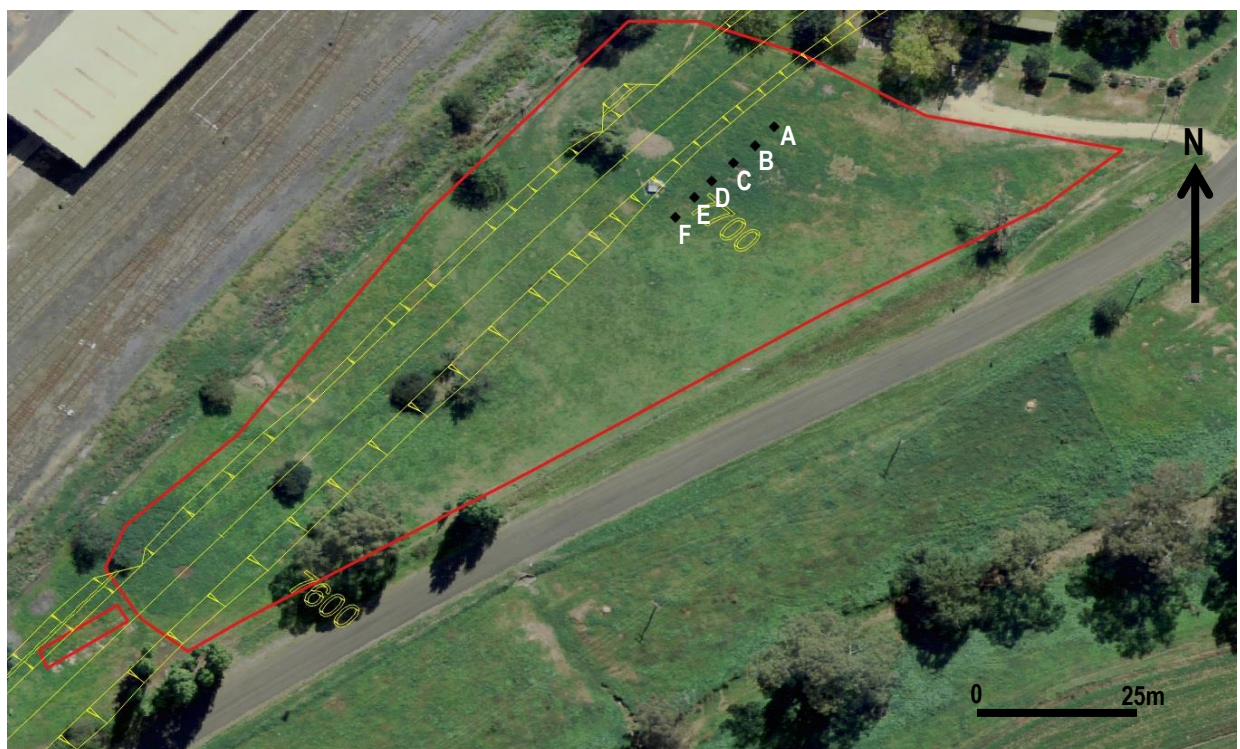
Figure 12. Probes at PAD 7

PAD 7 is located on the margins of a creekline tributary of the Lachlan River. It comprises a narrow terrace and gentle slopes on the western side of the creek. It is in a zone of considerable disturbance, with a bitumen road on the eastern side between the PAD and the creek, and the rail line to the west. A dwelling and sheds has been constructed to the north and there has been a structure at the area's southern extent in the past. Despite the potential for Aboriginal objects to remain at the site, the potential for the area to be disturbed is high. The area was tested with a single transect of six test pits spaced five metres apart (Figure 12, Plate 30).

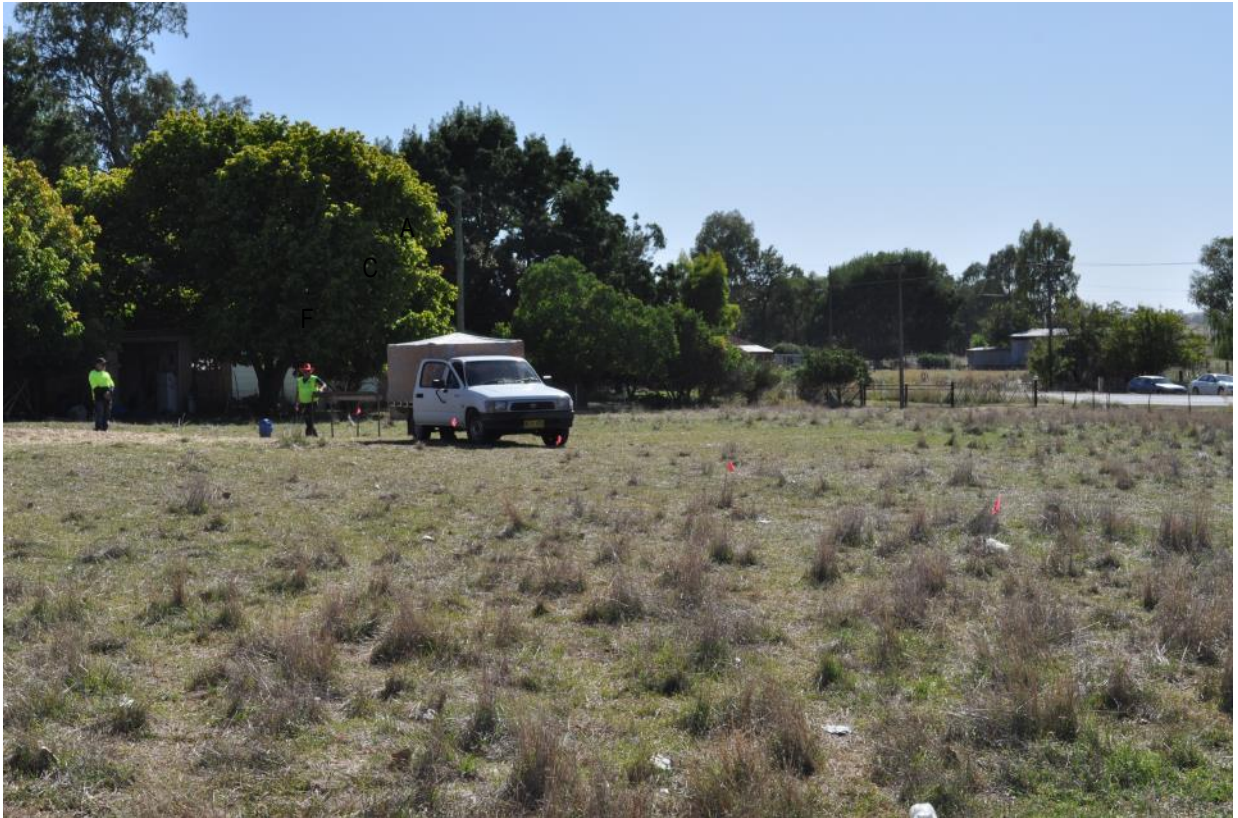
Plate 30. View north east across probes at PAD 7. Probe F marked by pink flag closest to viewer

PAD 7 exhibited a relatively deep soil profile, which would be expected as a creek terrace and generally aggrading land form. Overall probes averaged 650mm depth, and the top 450mm bore evidence of European occupation in the form of glass, metal and ceramic fragments of a variety of colours and sizes, though mainly small. Spits 1 and 2 of probe A contained dense slag and fire cracked rock suggesting the presence of a fire event in the recent past.

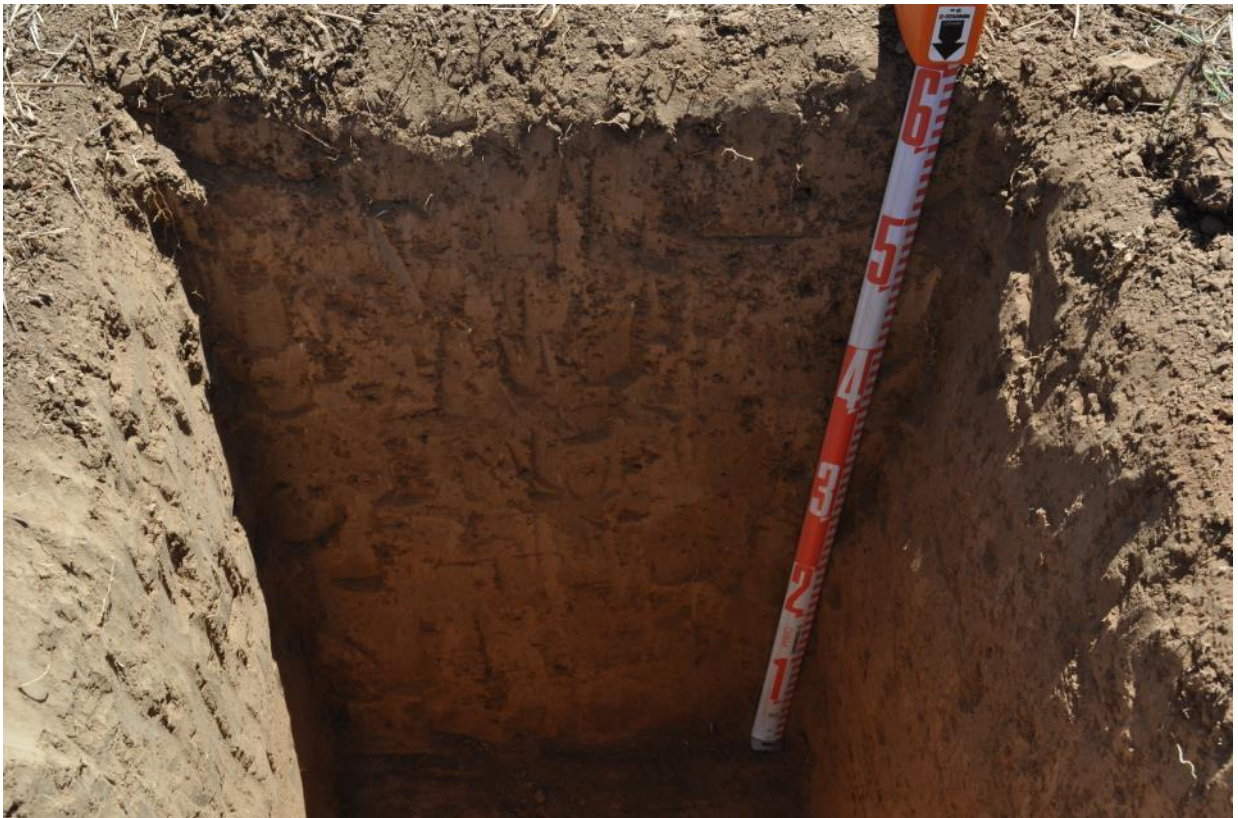
Plate 31. General soil profile, PAD 7
